DEPARTMENT OF TRANSPORTATION

Contract #: 04-0120F4Cty: SF/ALA Rte: 80 PM: 13.2/13.9File #: 1.28**WELDING INSPECTION REPORT****Resident Engineer:** Casey, William**Address:** 333 Burma Road**City:** Oakland, CA 94607**Report No:** WIR-027154**Date Inspected:** 07-Feb-2012**Project Name:** SAS Superstructure**OSM Arrival Time:** 700**Prime Contractor:** American Bridge/Fluor Enterprises, a JV**OSM Departure Time:** 1530**Contractor:** American Bridge/Fluor Enterprises, a JV**Location:** Jobsite**CWI Name:** As noted below**CWI Present:** Yes No**Inspected CWI report:** Yes No N/A**Rod Oven in Use:** Yes No N/A**Electrode to specification:** Yes No N/A**Weld Procedures Followed:** Yes No N/A**Qualified Welders:** Yes No N/A**Verified Joint Fit-up:** Yes No N/A**Approved Drawings:** Yes No N/A**Approved WPS:** Yes No N/A**Delayed / Cancelled:** Yes No N/A**Bridge No:** 34-0006**Component:** SAS OBG**Summary of Items Observed:**

WELDING INSPECTION REPORT

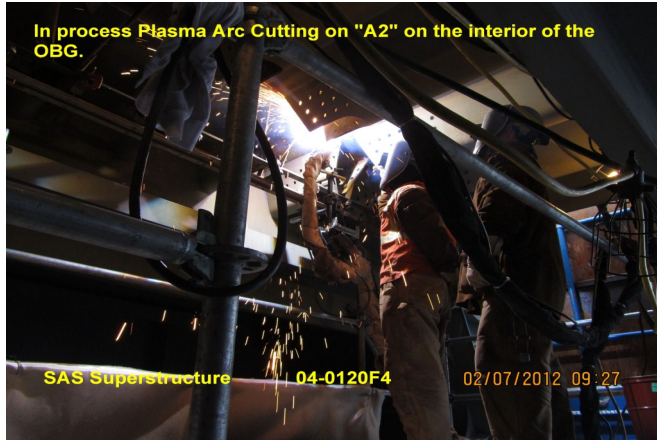
This QA Inspector randomly observed ABF welding personnel Wen Han Yu utilize the Plasma Arc Cutting (PAC) method to remove the backing bar from face "B" of "A2" at 12E/13E on the interior of the OBG. The welder employed the use of scaffolding to access the joint utilizing a "Bug-O" motorized rail system with a magnetic base attached in the (4G) overhead position to operate the PAC system. This QA Inspector noted the use of respiratory masks and proper safety procedures were followed. This QA Inspector made subsequent observations and noted that the work was in progress and appeared to be in general conformance with the contract documents.
